TARGET:

Sealing of a several leakage points located in the dam's upstream face.

WATER BASIN

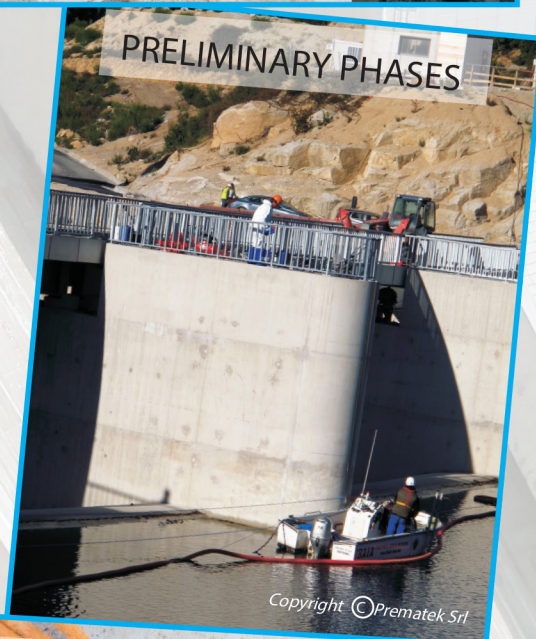
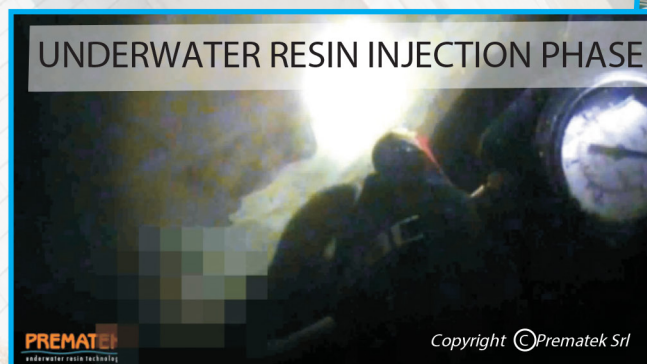
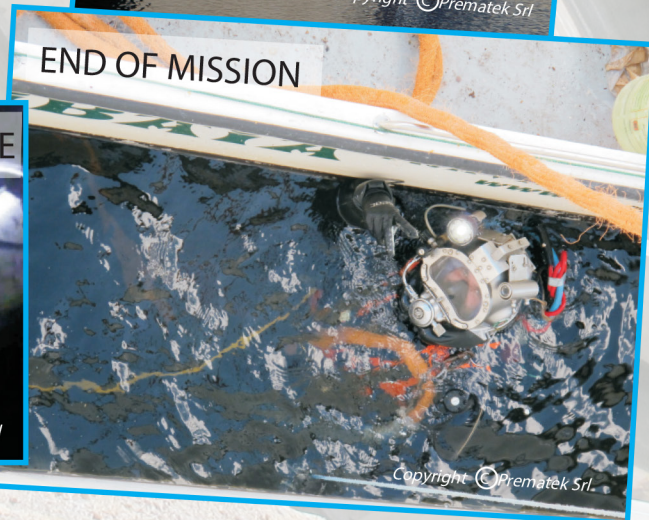
Polyurethane resin injection settled with ultra high speed reaction time.

Leakage water flow reduced from the initial 1500 liters/min to the requested 300 liter/min, with the possibility to seal it completely in the future.
